Experimental Investigation of Impact Localization in Composite Plate Using Newly Developed Imaging Method

Article

Abstract: This paper focuses on impact localization of composite structures, which possess more complexity in the guided wave propagation due to the anisotropic behavior of composite materials. In this work, a composite plate was manufactured by using a compression molding process with proper pressure and temperature cycle. Eight layers of woven composite prepreg were used to manufacture the composite plate. A structural health monitoring (SHM) technique was implemented with piezoelectric wafer active sensors (PWAS) to detect and localize the impact on the plate. There were two types of impact event that were considered in this paper (a) low energy impact event (b) high energy impact event. Two clusters of sensors recorded the guided acoustic waves generated from the impact. The acoustic signals were then analyzed using a wavelet transform based time-frequency analysis. The proposed SHM technique successfully detected and localized the impact event on the plate. The experimentally measured impact locations were compared with the actual impact locations. An immersion u

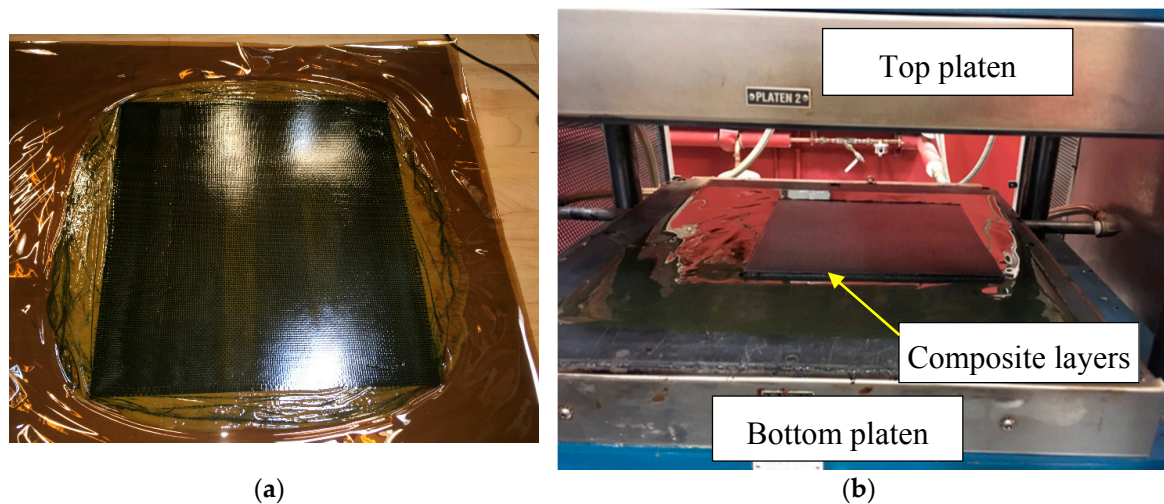
Figure 1. Composite layers (a) with thin protective films (b) in the compression-molding machine.

The prepreg was cut to the desired shape (square in this case) with a dimension of 305 mm by 305 mm (12 inches by 12 inches). Each cutting section served as a layer. Eight layers of woven fabric were then stacked upon each other to form a laminate. Two thin protective films of plastics with a very high melting point were used on top and bottom of the stack up (Figure 1a). The laminate of eight layers was then placed between two flat platens of the compression-molding machine, as shown in Figure 1b. The melting temperature of the PPS fabric was 536 °F. A cure cycle must contain a temperature higher than the melting point for proper melting and the flow of the resin. Figure 2a shows a standard cure cycle used for this laminate. A constant pressure of 150 psi was applied during the cure cycle. Heating was adjusted in the compression-molding chamber for raising the laminate temperature to 610 °F within 45 min. Then the temperature of the laminate dwelled at 610 °F for 30 min. At the end of dwell time, the laminate was air cooled from 610 °F to room temperature in 30 min. After the cure cycle completed in about 2 h, the laminate was taken out from the platen. The extra resin flow at the edges of the laminate was trimmed. Figure 2b shows the final composite laminate after the trimming process. The resulting plate had a thickness of 1.6 mm. The dimension of the final composite plate was 387 mm by 276 mm (11.3 inches by 10.9 inches).

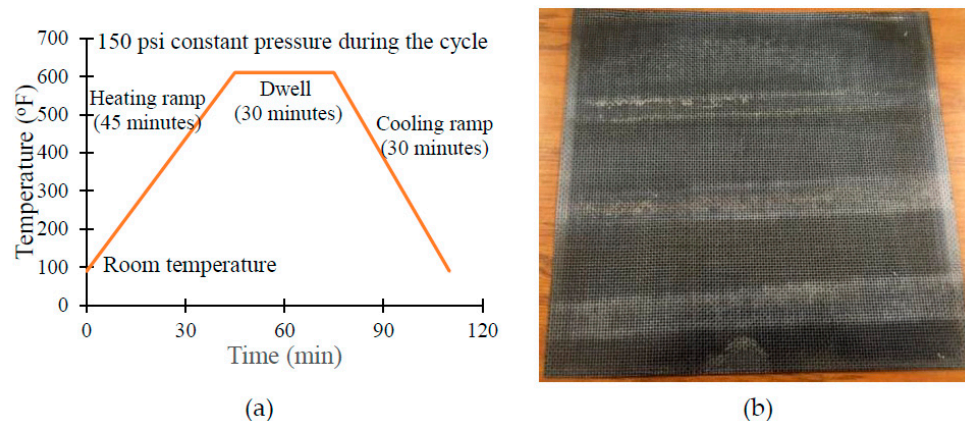
Figure 2. (a) Cure cycle for the PPS prepreg; (b) Final composite plate.

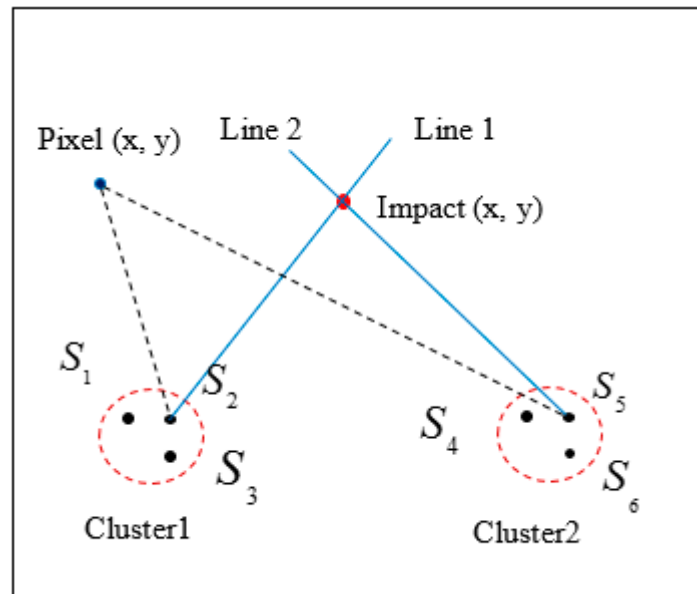
Figure 3. Mapping of two lines from each cluster to show the intersection at the impact location (black dotted lines from each cluster mapped on the pixel and blue solid lines intersected at the impact location).

We developed a new imaging method of acoustic source localization in anisotropic plates due to the impact event. In this method, two clusters of sensors (every cluster has three sensors) were used to localize the impact points as shown in Figure 3. To localize the impact point using imaging methods, we divided the region of interest into small pixels. The first step of this imaging approach was to determine the slope values for every cluster based on the time of flight of impact signals received by the clusters sensors [23,24]

where $P_{sum}(x, y)$, $P_{mult}(x, y)$ are the total field values of each pixels using a summation or multiplication algorithm. N represents the total number of sensing path lines which equal to the total number of clusters. In this work, we have used two clusters. Two-line paths from each cluster are

mapped over the pixels and intersected at the impact point as shown the Figure 3. Figure 4 shows the detail procedures of the imaging method.

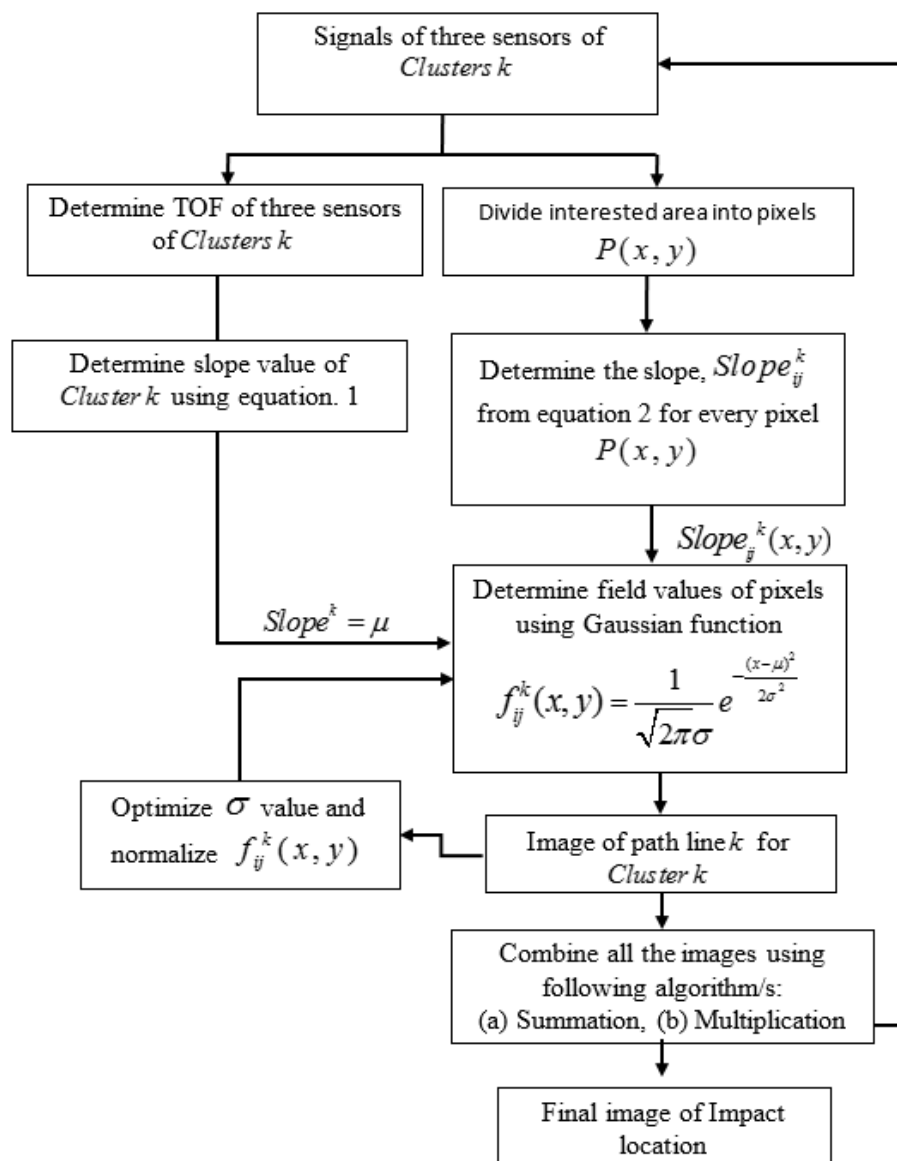
Figure 4. Flowchart of the developed imaging method.

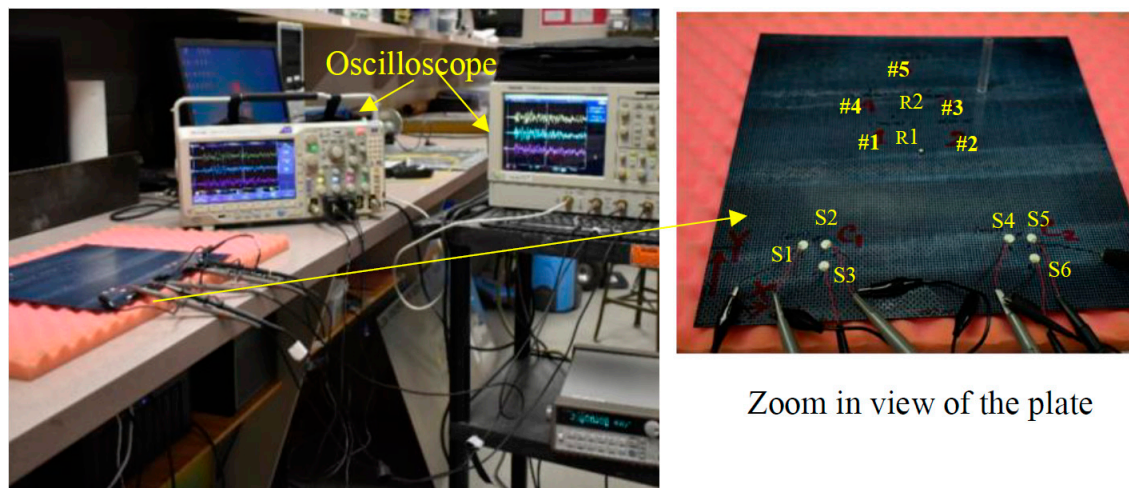
Figure 5. Experimental setup for impact detection and localization on the composite plate.

The experimental setup is shown in Figure 5. Two clusters of PWAS sensors were used as named Cluster1 (at coordinate location (60, 53)) and Cluster2 (at coordinate location (197, 53)). In each cluster, there were three PWAS transducers placed at 90 deg. Orientation. The configuration of these sensors are especially useful when one does not know the exact material properties of the plate. This method can accurately predict the location of the impact by analyzing the received signals by the sensors without knowing the material properties. Signals from an impact location were received through six sensors using two oscilloscopes (Figure 5).

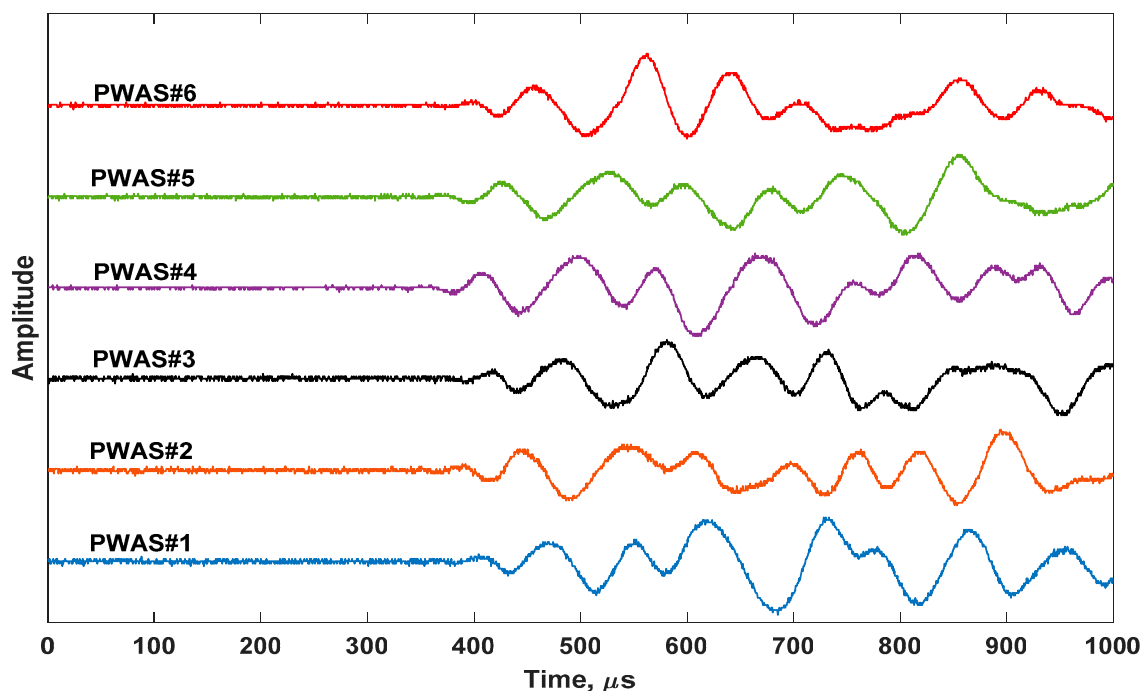
Figure 6. Piezoelectric wafer active sensors (PWAS) recorded acoustic signals due to low-energy impact at location #3 (150, 200) mm.

The six signals from the six sensors are illustrated in Figure 6. Figure 6 corresponds to the signals received from impact location #3. Only the low-energy impact at location #3 is presented here as a representative result. These signals received by the sensors indicate that there was an impact event. In this experiment, low energy impact (height was intentionally kept low) was used to show how sensitive the proposed SHM system is. In the case of high energy impact, it would be much easier to detect the impact event since it would produce higher amplitude AE signals.

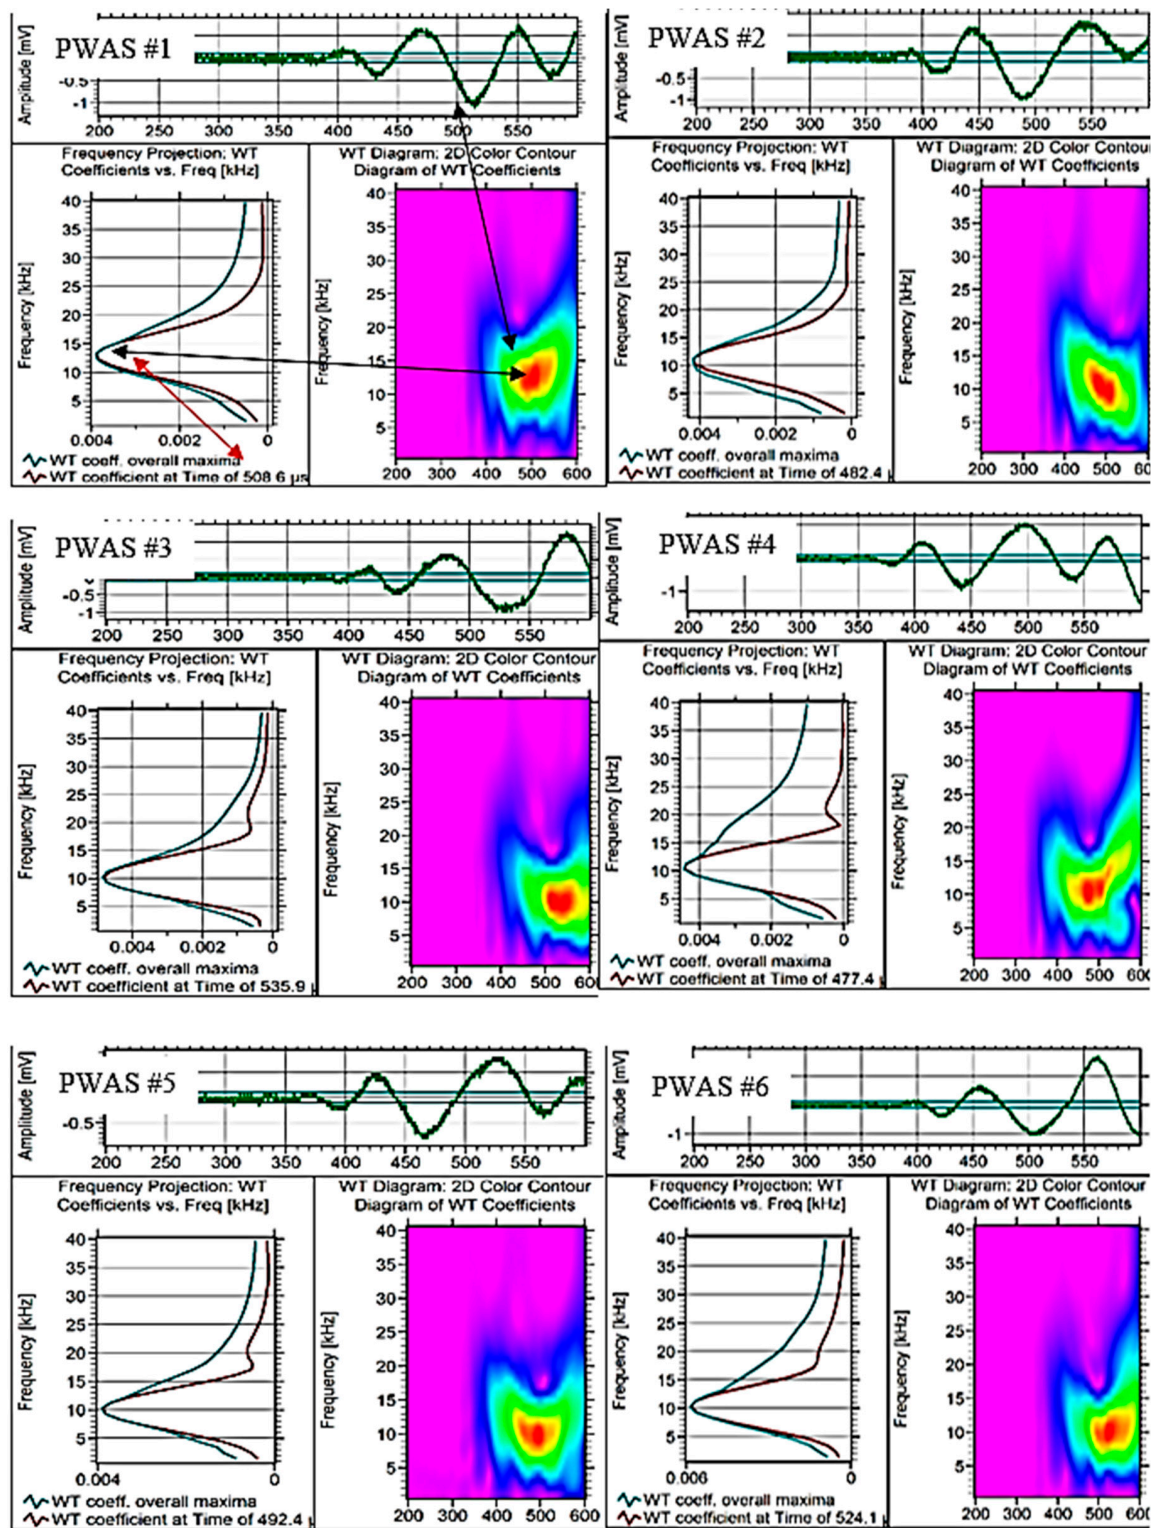
Figure 7. Wavelet transform of the PWAS recorded signals to determine the time of flight (TOF) (for low-energy impact location #3).

The WT diagrams in Figure 7 show the frequency-time plot using the WT. It shows the amplitude mapping over various frequencies and time. At each time and frequency, a WT coefficient variation can be plotted as shown on the bottom-left of each box. An overall maximum of the WT coefficient has been plotted. The time at which the WT profile matches the overall WT maxima provide the TOF. This process has been repeated for all PWAS signals to determine the TOFs.

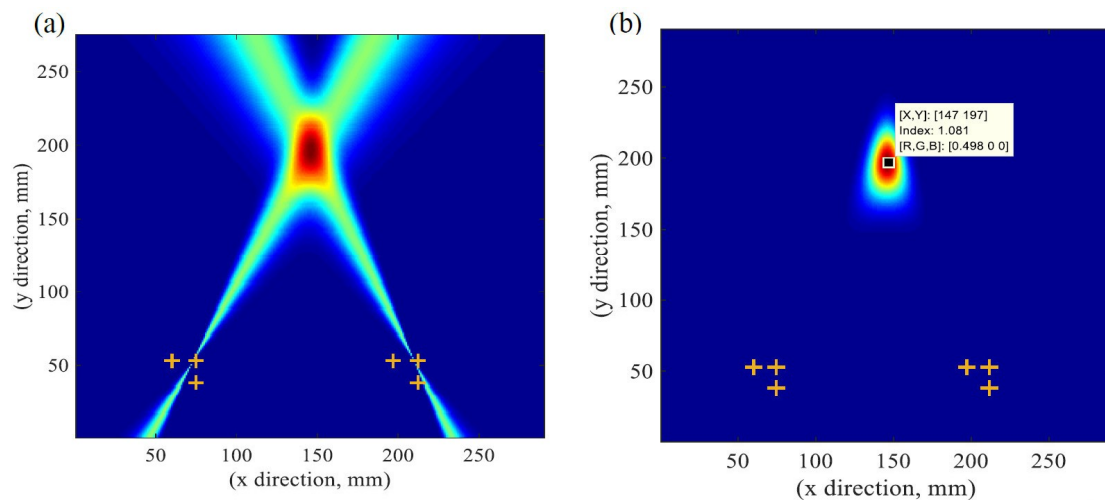
Figure 8. Imaging results of localization low-energy impact at point #3 (150, 200) mm using imaging methods; (a) summation method; (b) multiplication method (+ sign corresponding to different sensors location).

Once the TOFs for all the AE signals were known, a localization algorithm was used to determine the impact location. The imaging method is described in the earlier section (Section 3.1). The results from the imaging method are illustrated in Figure 8. The experimental measurement and the actual impact location is summarized in Table 1. The visual representation of the actual impact location and measured impact location is shown in Figure 9. It shows that the experimentally measured impact locations are in good agreement with the actual impact location.

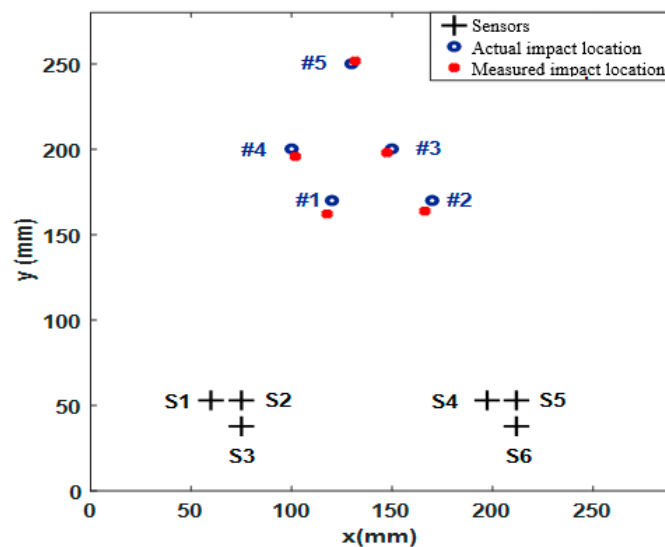
Figure 9. Experimentally measured low-energy impact location and actual impact location on the manufactured composite plate.

Impact Event	Actual Location (x, y) mm	Measured Location (x, y) mm	% of Error (Based on Sensor Cluster1)
#1	(120, 170)	(117.7, 161.9)	6.7%
#2	(170, 170)	(166, 163.8)	4.8%
#3	(150, 200)	(147.4, 197.8)	1.9%
#4	(100, 200)	(101.8, 195.5)	2.7%
#5	(130, 250)	(131.7, 251.6)	0.9%

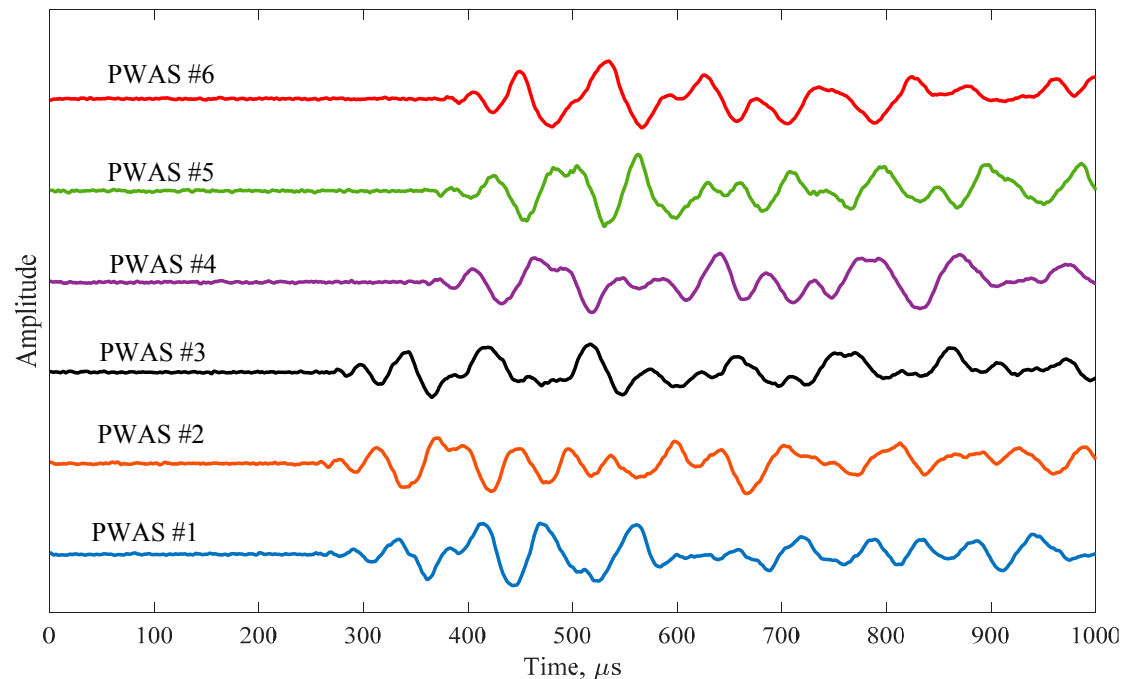
Figure 10. PWAS recorded acoustic signals due to the high-energy impact at location #R1 (128, 167 mm).

The sharp point cylinder was freely impacted from 1 m height following a special guide fixture to create 9 J impact energy. The six signals from the six sensors are illustrated in Figure 10. Figure 10 corresponds to the signals received from impact location R1.

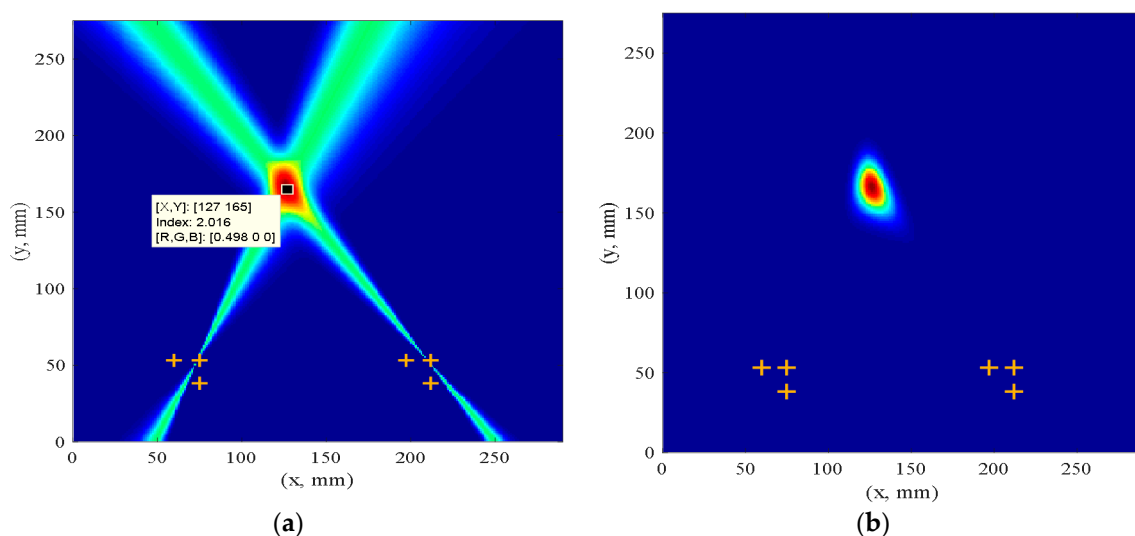
Figure 11. Imaging results of localization high-energy impact at point #R1 (128, 167) mm using imaging methods; (a) summation method; (b) multiplication method (+ sign corresponding to different sensors location).

A wavelet transform based method was used to determine the TOF as described in the previous section (Section 3.3.2). Figure 11 illustrates the impact location of high-energy impact using the developed imaging method. The experimental measurement and the actual impact location is summarized in Table 2. It can be observed from Table 2 that the impact location determined by the current approach is very accurate compared to the actual impact location.

Impact Event	Actual Location (<i>x, y</i>) mm	Measured Location (<i>x, y</i>) mm	% of Error (Based on Sensor Cluster1)
#1	(128, 167)	(127, 165)	2.4%
#2	(147, 207)	(146, 204)	2.8%

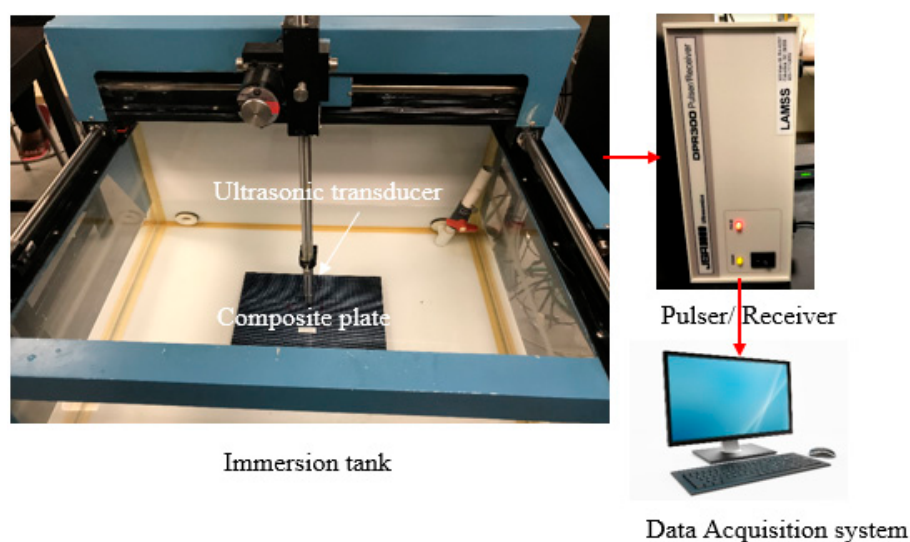
**Figure 12.** Experimental setup for the ultrasonic inspection of composite plate under water.

In immersion testing, the transducer is placed in the water, above the test object, and a beam of sound is projected. The experimental setup of immersion ultrasonic testing is shown in Figure 12. A 10 MHz 0.37-inch diameter-1-inch focused transducer was used for pulse-echo measurement. A pulser/receiver was connected to the transducer. Pulser/receiver simultaneously transmits and receives the signal. A data acquisition system was used to collect the data. The scan area of the composite plate is shown in Figure 13. A 2-inch by 2-inch area was scanned first for detecting the manufacturing damage and flaws in the composite plates. Figure 14 shows the C-scan image before the impact event. It can be seen clearly from the figure that there are no significant manufacturing defects, damage or flaws in the composite plate. Figure 15 shows the C-scan image after the high-energy impact event. There are two high-energy impact events at location R1 and R2. A 1-inch by 1-inch area was scanned first for visualizing the defect due to a high-energy impact event. Figure 15a,b shows the evidence of impact damage at R1 and R2 location. The size of the impact damage is around 2.5 mm in diameter. From Figure 15a, slight delamination can also be observed around the impact location.

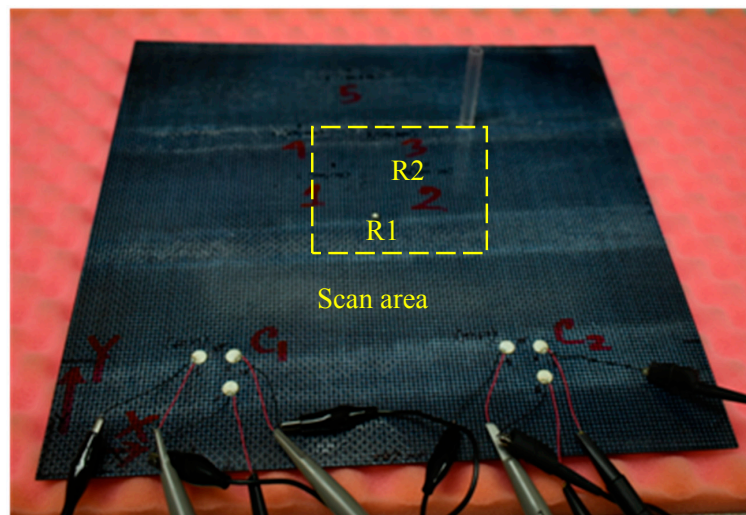
Figure 13. Scan area of the composite plate for immersion ultrasonic inspection.

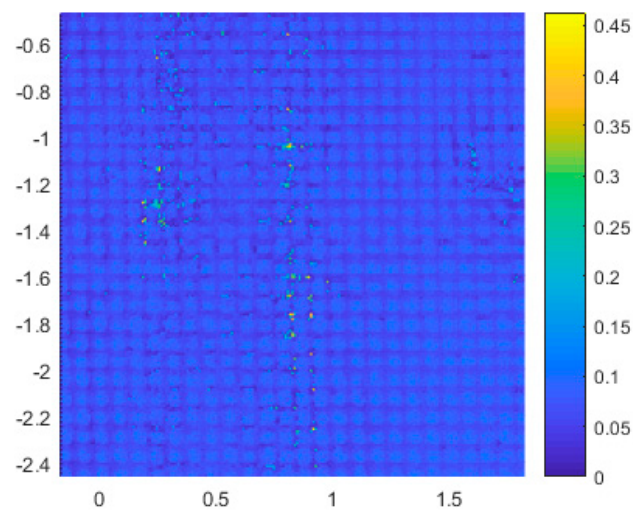
Figure 14. C-scan image of the composite plate for manufacturing defect inspection.

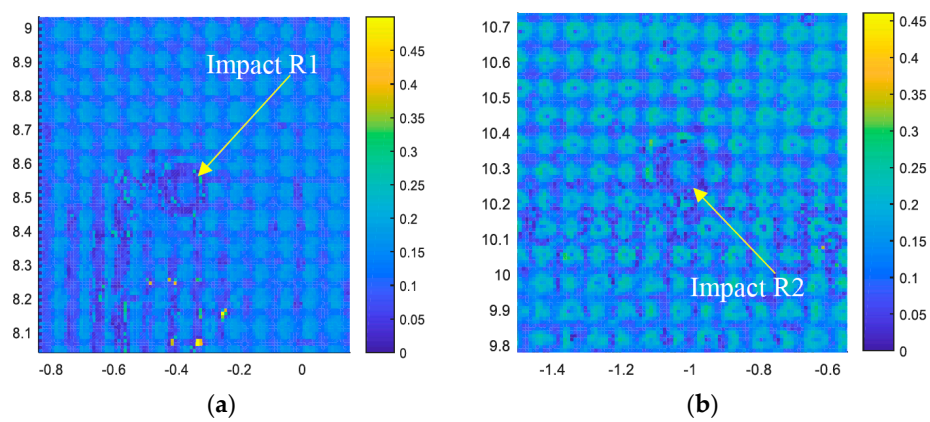
Figure 15. C-scan image of the composite plate after high-energy impact event (a) impact at R1 location (b) impact at R2 location.
